Road Safety Audit
Fort Johnson Road at Secessionville Road
and Fort Johnson Road at Camp Road

Short-Term Improvements:
Secessionville Road at Fort
Johnson Road

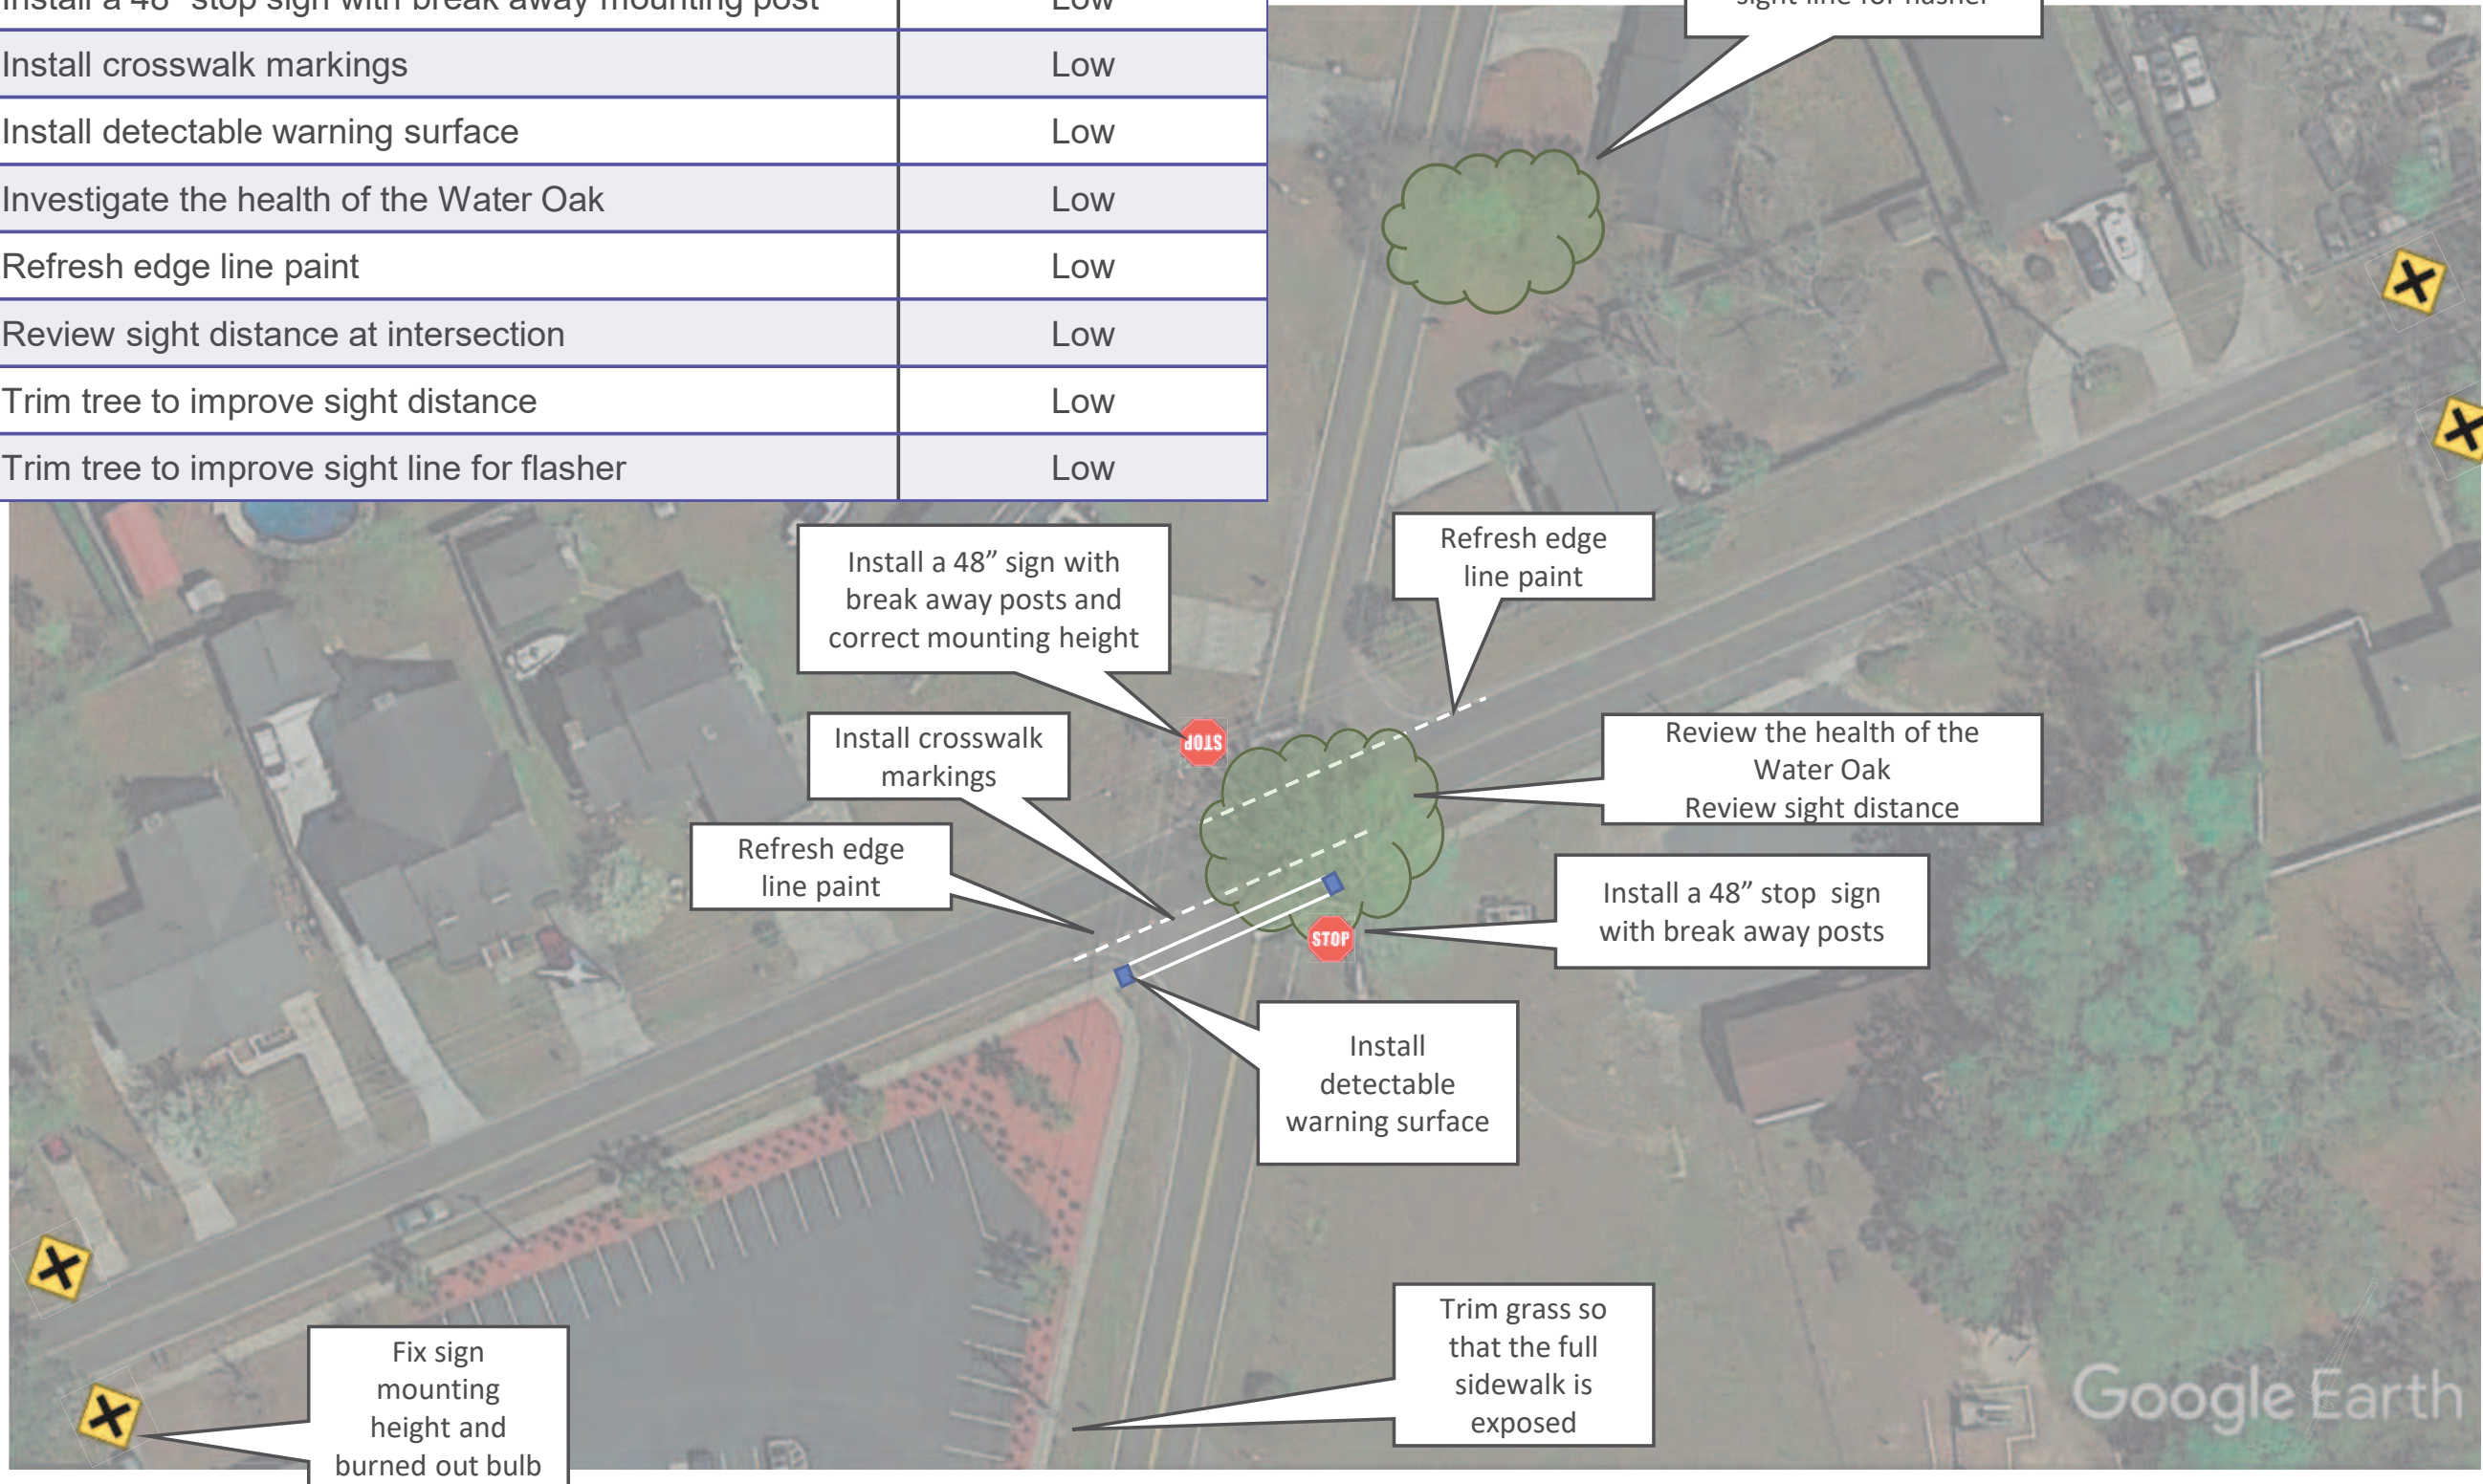
Figure 1

Improvement	Order of Magnitude Cost
Fix sign mounting height and burned out bulb	Low
Install a 48" stop sign with break away mounting post	Low
Install crosswalk markings	Low
Install detectable warning surface	Low
Investigate the health of the Water Oak	Low
Refresh edge line paint	Low
Review sight distance at intersection	Low
Trim tree to improve sight distance	Low
Trim tree to improve sight line for flasher	Low
