CONCEPTUAL PLANS  
FOR REVIEW  
JUNE 2025

MAYBANK HIGHWAY  
TRADITIONAL WIDENING - 11' LANES

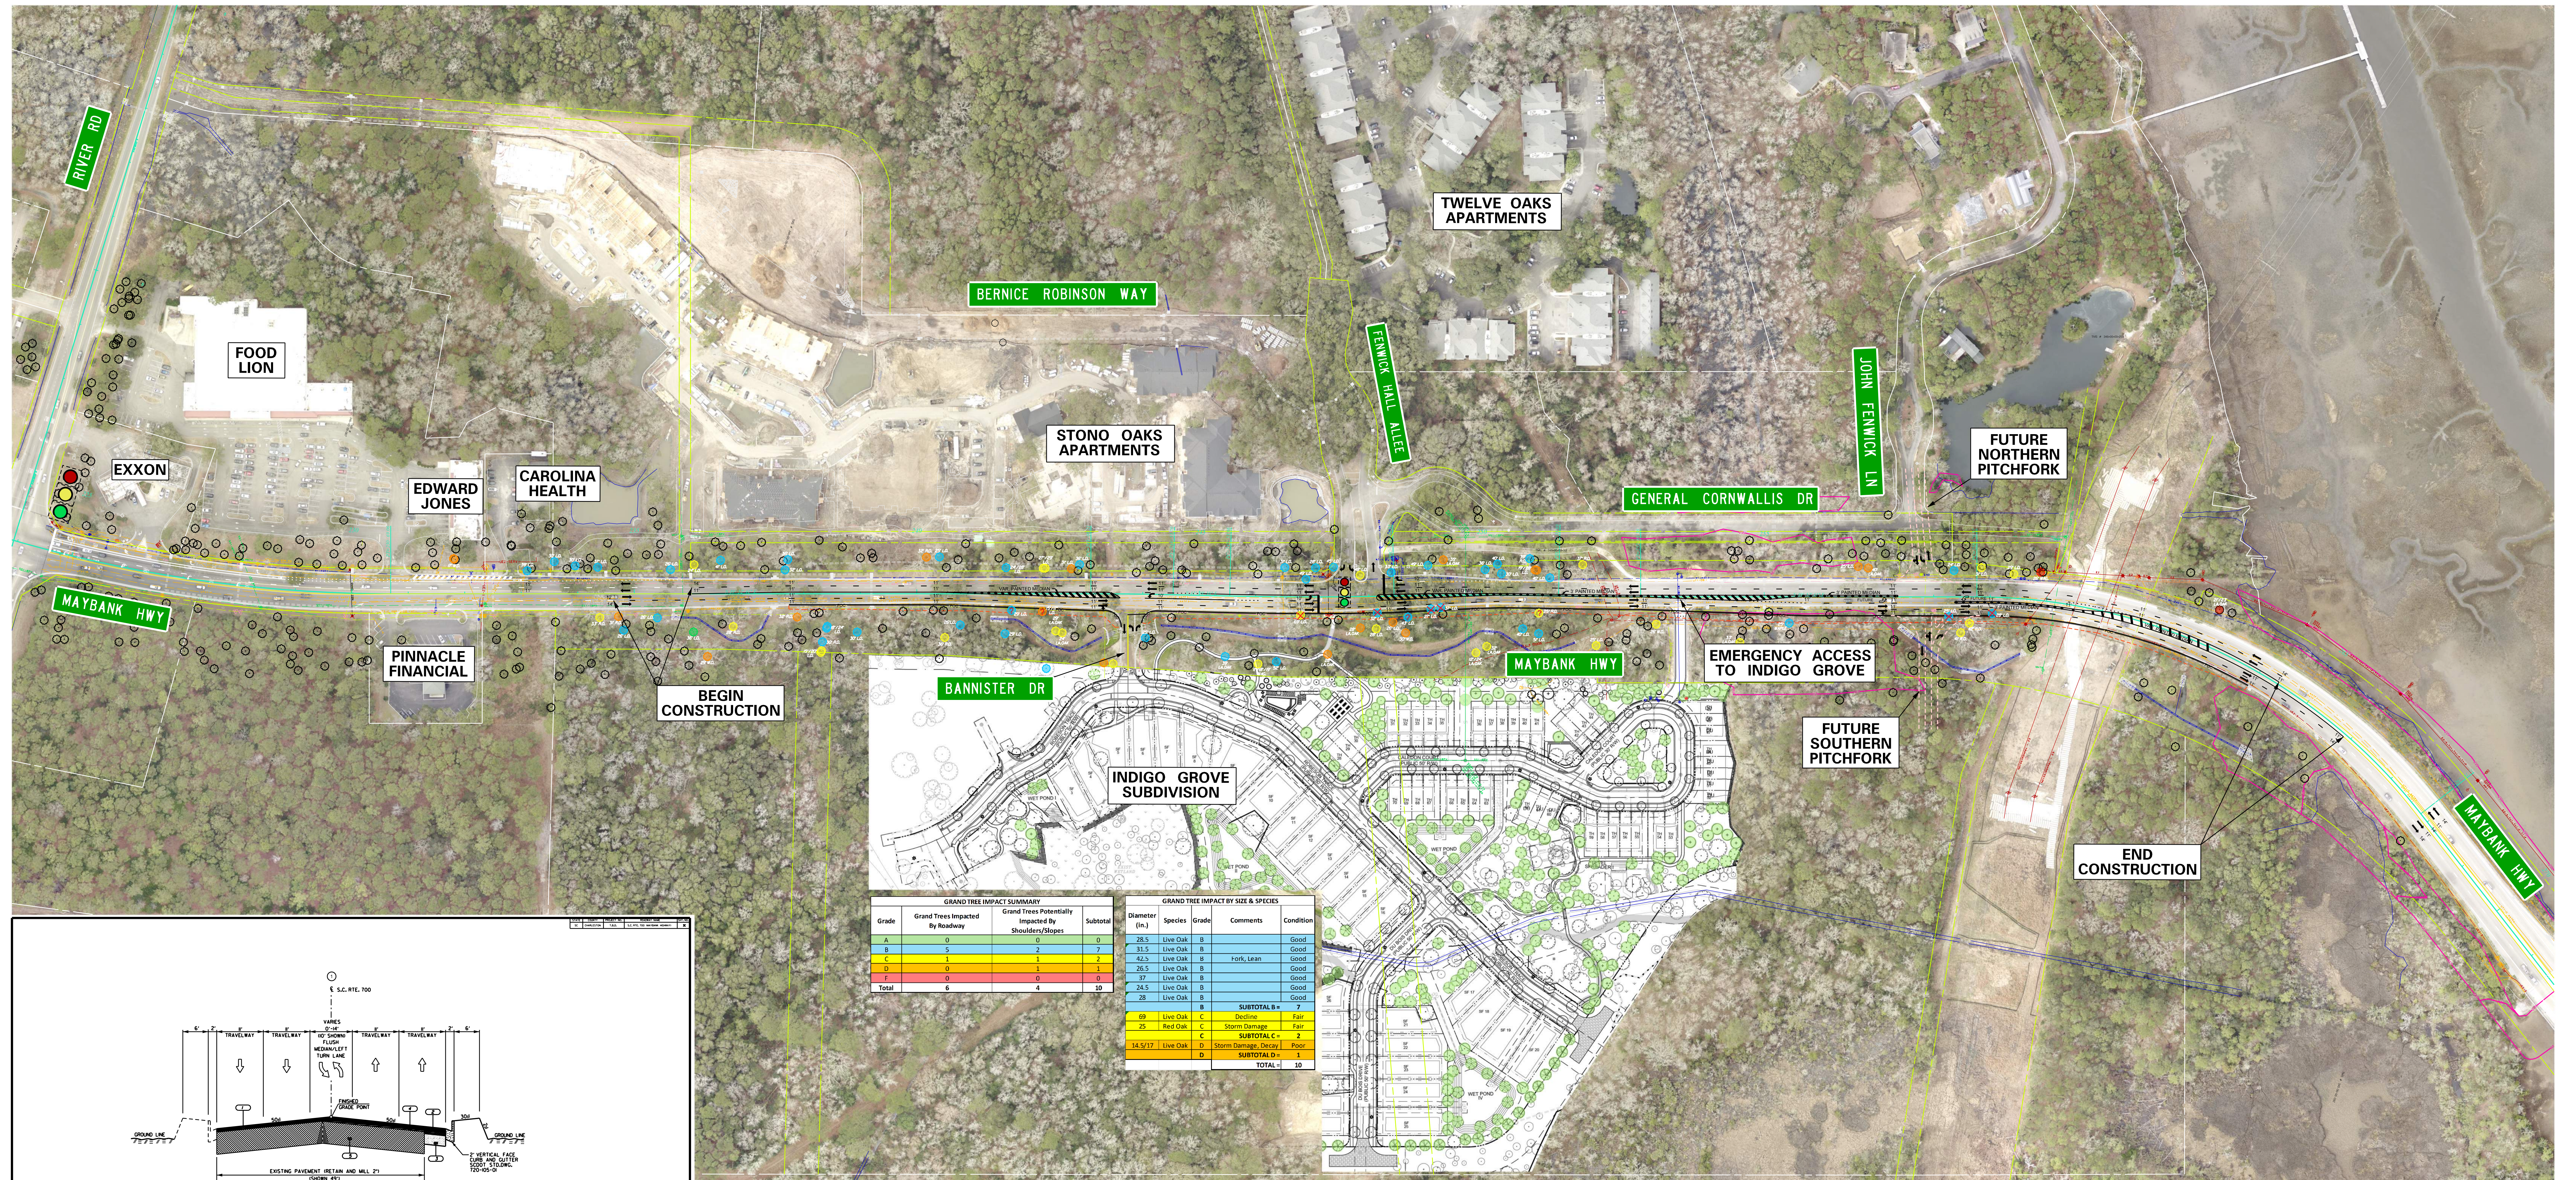
| GRAND TREE IMPACT SUMMARY | | | |
| Grade | Grand Trees Impacted By Roadway | Grand Trees Potentially Impacted By Shoulder/Slopes | Subtotal |
| Total | 6 | 4 | 10 |

| GRAND TREE IMPACT BY SIZE & SPECIES | | | | |
